Intel® Acceleration Stack for Intel® Xeon® CPU with FPGAs Version 1.1 Release Notes

Intel FPGA Programmable Acceleration Card N3000

RN-1219

Version: **2021.07.01**

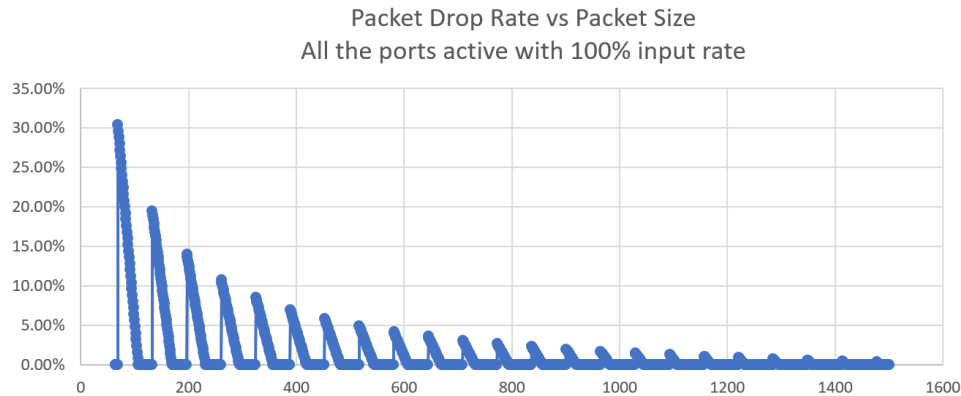
Figure 1. Predicted Packet Loss Rate for 2x2x25G and 4x25G Configurations

The FPGA factory image multiplexes all the Ethernet ports into one 512-bit (64 byte) bus. This bus has enough bandwidth to transport all the Ethernet ports when the packet size is a multiple of 64 bytes. When packet sizes are not multiples of 64 bytes, the last transfer of the packet on the bus carries the remainder of packet and the unused byte lanes do not carry valid data. For these packets, the bus does not have sufficient bandwidth to carry all traffic for some packet sizes. As a result of lack of bandwidth, the packet drops.

During internal tests, if all ports are active with fixed size packets that are not multiples of 64 bytes, some packet loss may occur. The worst case is 69-byte packets where the cyclic redundancy check (four bytes) is stripped off, resulting in 65 bytes transferred on the internal bus. This packet transfer takes two clock cycles. The first clock cycle transfers 64 bytes and the second clock cycle transfers one byte.

The following figure shows the predicted packet loss rate for the 2x2x25G and 4x25G network configurations when all the ports have 100% input capacity and same packet size.

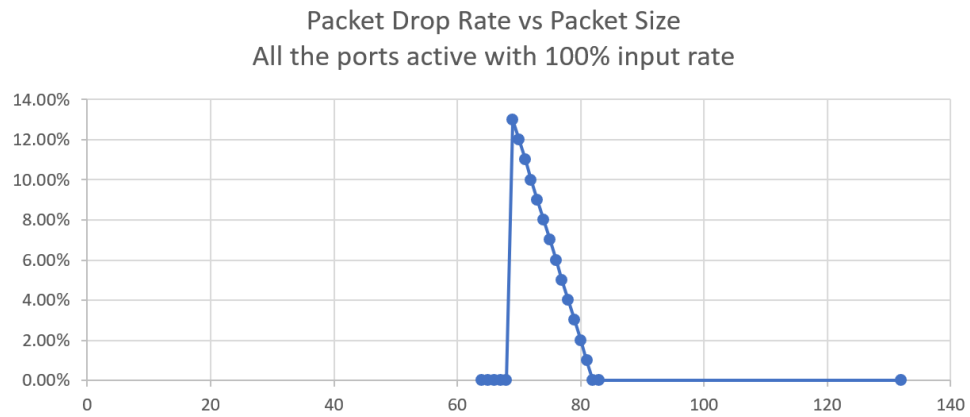
Figure 2. Predicted Packet Loss Rate for 8x10G Configuration

The following figure shows the predicted packet loss rate for the 8x10G network configuration when all the ports have 100% input capacity and same frame size. Packet loss only occurs for packet sizes between 69 bytes to 82 bytes.
